ANNUAL REPORT FOR 2010

**Roanoke River Overflow Mitigation Site
Northampton County
TIP No. B-1303**

Prepared By:
Natural Environment Unit & Roadside Environmental Unit
North Carolina Department of Transportation
June 2010

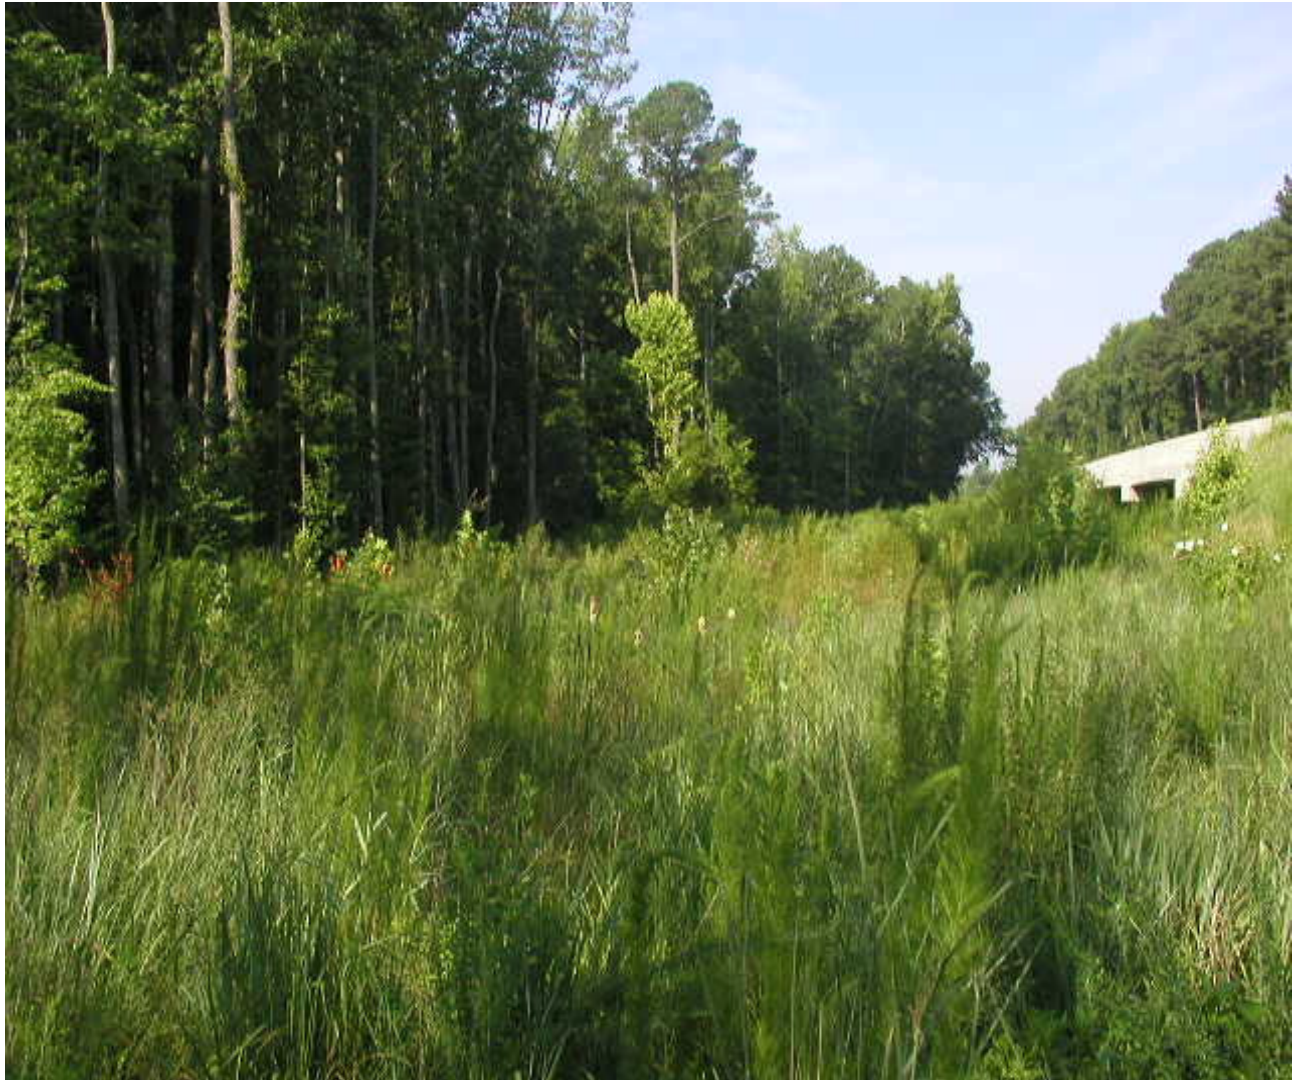
Photo 1

Site Notes: The restoration area is re-attaining wetland jurisdictional status and the planted species are surviving. The site had small pockets of standing water at the time of monitoring. Other species noted: *Juncus* sp., black willow, red bud, fennel, cattail, smartweed, briars, red maple, sedge, pokeberry, ragweed, lespedeza, stinkweed, mimosa, locust and other various wetland species.

NCDOT proposes to discontinue vegetation monitoring at the Roanoke River Overflow Mitigation Site.
